NDT DAMAGE DIAGNOSIS ON SANDSTONE - Case Study of Gelnhausen, Germany

Christoph Franzen*; Thomas Löther*; Michael Auras** and Enno Steindlberger** *Institut für Diagnostik und Konservierung an Denkmalen in Sachsen und Sachsen-Anhalt e. V., Arbeitsstelle Dresden, Schloßplatz 1, D-01067 Dresden, www.idk-info.de, franzen@idk-info.de **Institut für Steinkonservierung e.V., Große Langgasse 29, D-55116 Mainz, www.ifs-mainz.de

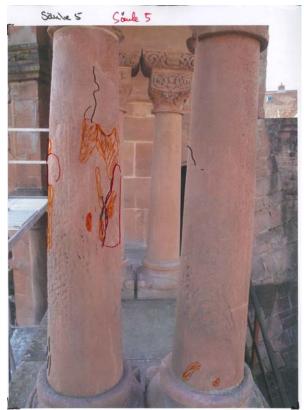
On pillar No. 5 (Fig. 4) active IRT was conducted. The pillar shows differential erosion and alveolisation in its lower parts. Previous typical damage investigation assumed subsurface detachments in the middle part of the pillar. This part was taken for specified investigations. Heater was placed normal to the central part of the pillar at a distance of 1.3 m for 300 s. Every 5 s IR-thermogram was captured. The total measurement sequence covered the activation and the cooling phase of the area investigated (Fig. 5, 6). Also here interpretation was done on the difference-temperature-thermograms.

Figure 4: Pillar 5 (left), previous damage mapping, suspicion of subsurface detachment areas.

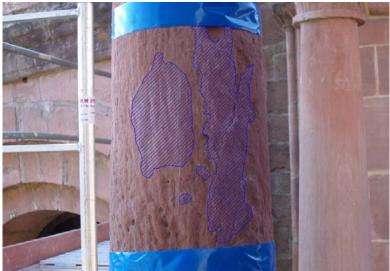
From both investigation phases, activation and cooling, thermograms were taken as basis for interpretation. Thermal anomalies were interpreted as detachment areas and hatched. In comparison to the previous damage mapping (Fig. 4) the IRT damage detection yields high correlation to the detachment area on the right hand side of the pictures (Fig. 5, 6). On the left hand side, divided by the vertical crack, a subsurface detachment was detected, which was not detected before.

Figure 7: Results of IRT mapping drawn into the photograph.

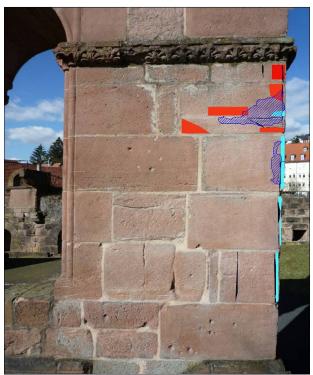
On the eastern pylon passive IRT was proceeded. From investigation with the acoustic Lehrberger Kugel detachments at the sandstone squares was known. In Fig. 8 these areas are given in red colour. IRT was proceeded when the sun was shining on the masonry. Areas of detachment were clearly visible due to temperature anomalies on the surface (Fig. 9). These results were transcripted into the foto (Fig. 8). The challenges in consistency between the two procedures have to be discussed.

Figure 8: Eastern pylon with damage of resonance sound detector (red) and damage detection by IRT (hatched blue).

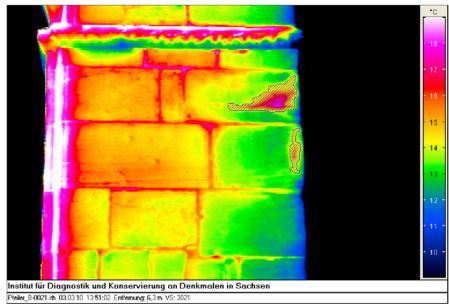
Figure 9: Passive IRT on eastern pylon, damage areas hatched.
